Land Subsidence Rate in the Elfrida Area, Cochise County
Based on ERS-1 and 2 Satellite Interferometric Synthetic Aperture Radar (InSAR) Data
Time Period of Analysis: 1.0 Years 01/06/1996 To 12/24/1996

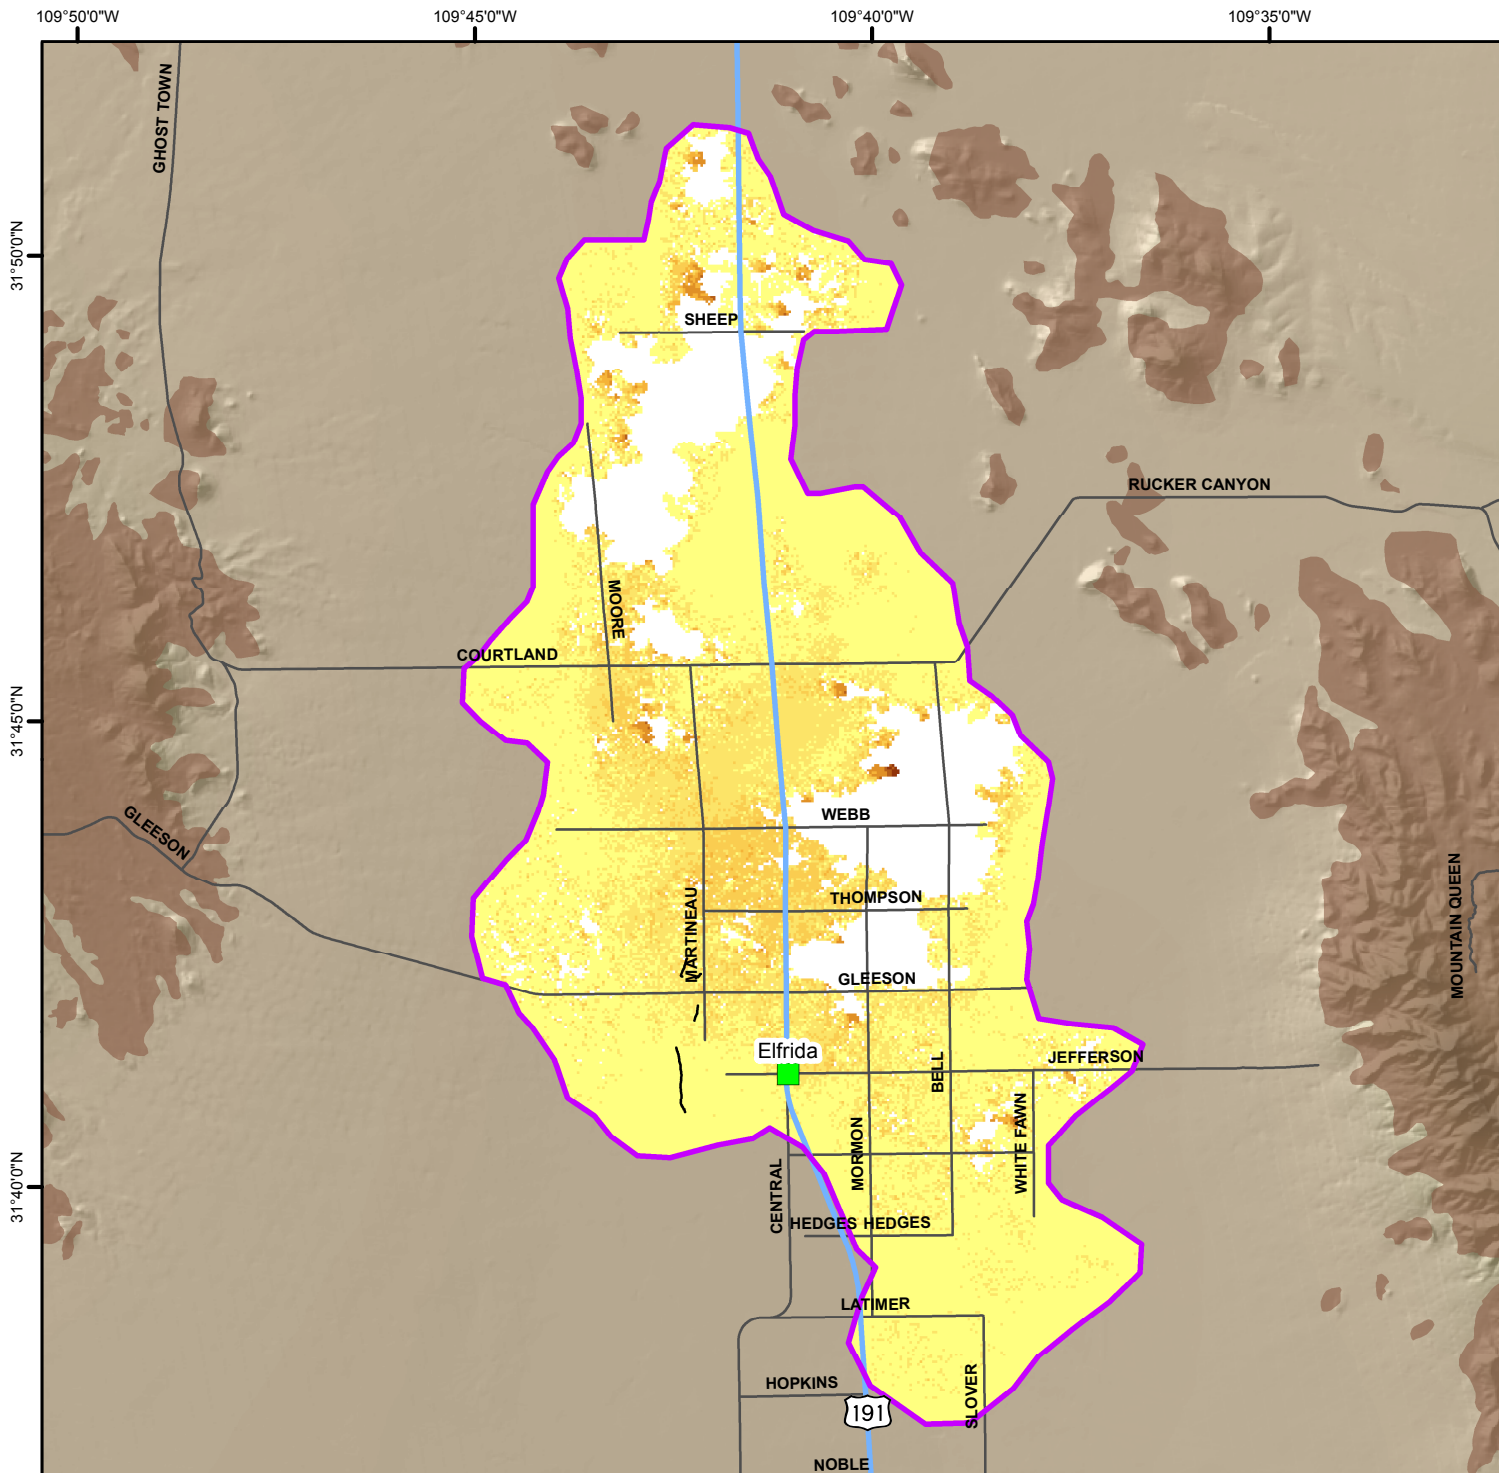
Decorrelation (white areas) are areas where the phase of the received satellite signal changed between satellite passes, causing the data to be unusable. This occurs in areas where the land surface has been disturbed (i.e. bodies of water, snow, agriculture areas, areas of development, etc).
